MARYLAND INVENTORY OF
HISTORIC PROPERTIES

Survey No. B-4327

Kruger's Restaurant

street & number 21-23 N. Howard Street

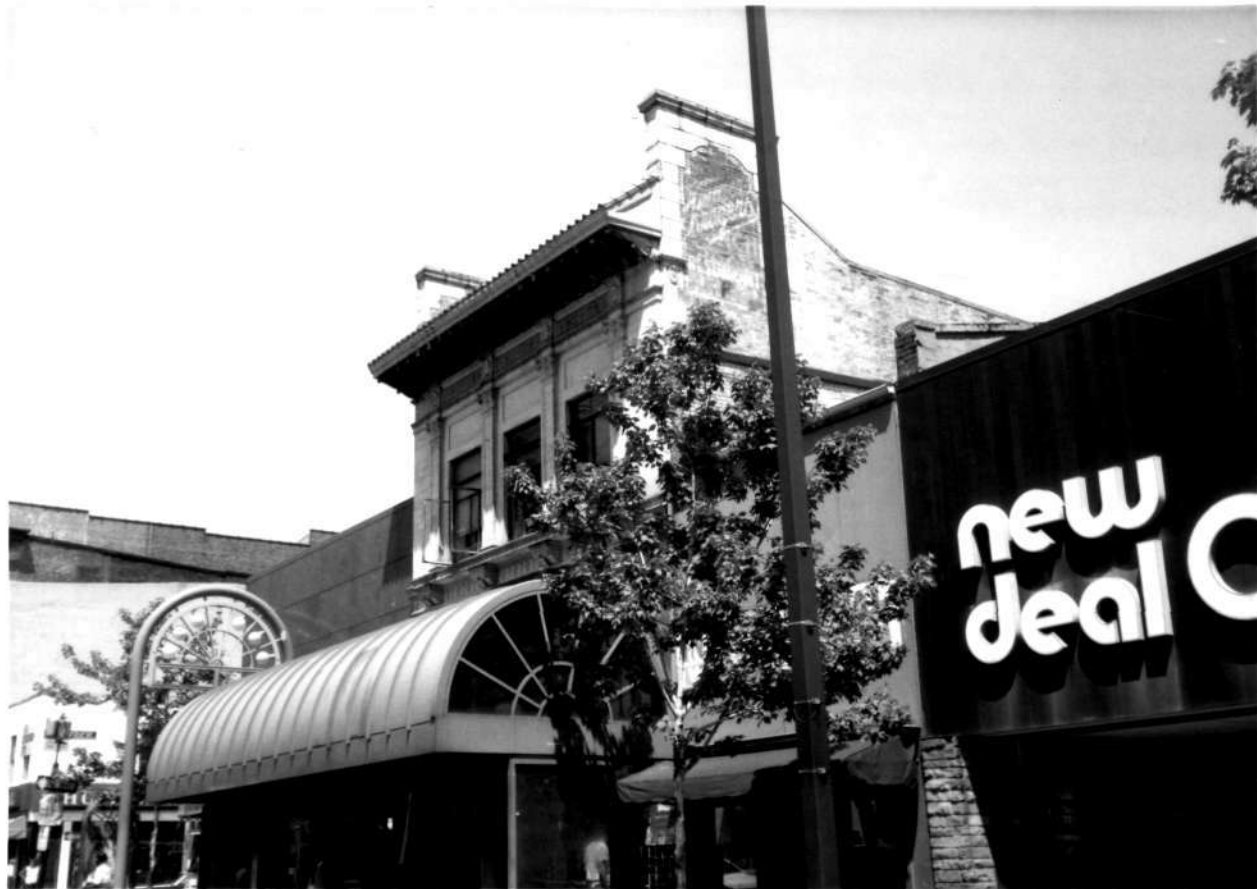
1/3

Exterior, SW Elevation

The first story has been remodelled into an enframed window wall design with polished granite revetments bordering the glazed doors and windows. To the north is an angled, recessed entryway with glass double doors and transom linked to the first-story unit #21. To the north of this entryway is a small display window in the "jambs" of the recessed entry. To the south of this entryway of a plate glass display window that angles out to the plane of the sidewalk. The entryway and flooring under the display window is tiled and elevated upon a stone sill. To the south of the enframed window wall is a single glazed door that leads to the stair hall serving the upper stories at #21. The wall surface around the doors and windows are covered with brown metal sheets. A roll-down theft guard is suspended over #23. An awning stretches across the facade. Sheet metal panels rise above the awning, and are enframed on the sides and top by additional polished granite revetments.

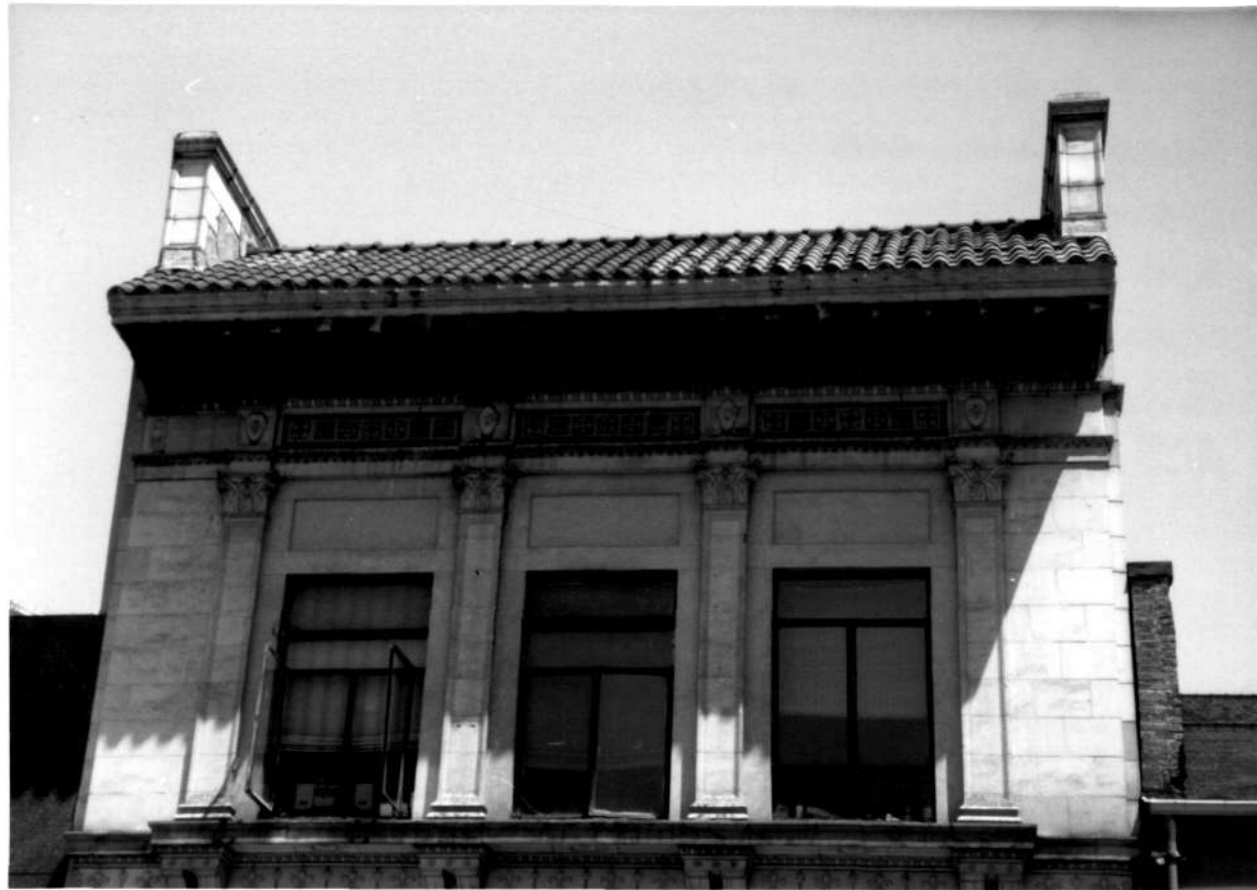
2/3

Facade detail, 2nd story

The second story is relatively unaltered. Four stone Corinthian pilasters divide the facade into three bays. The windows in the first and second bays are paired metal casements with double transoms. The window in the second bay has retained its embellished transom bar. The third bay has a replacement pair of casements that are shorter than the original pair; there is a transom above and below these casements. Stone spandrels are recessed above the transoms.

The pilasters support a plain entablature whose profile follows the breaking forward of the pilasters and recessing of the spandrels. Above this entablature is an ornate decorative band. The band consists of a flat entablature that has shields set in recessed fields that are positioned over the pilasters. Between the shields in each of the three bays are bands of seven blue and yellow glazed tiles. The seven tiles have the following patterns: 1) four leaves, 2) a fleur-de-lis, 3) a cross within a diamond, 4) four leaves, 5) a cross within a diamond, 6) a fleur-de-lis, and 7) four leaves. A row of stone egg and dart molding runs along the top of the band.

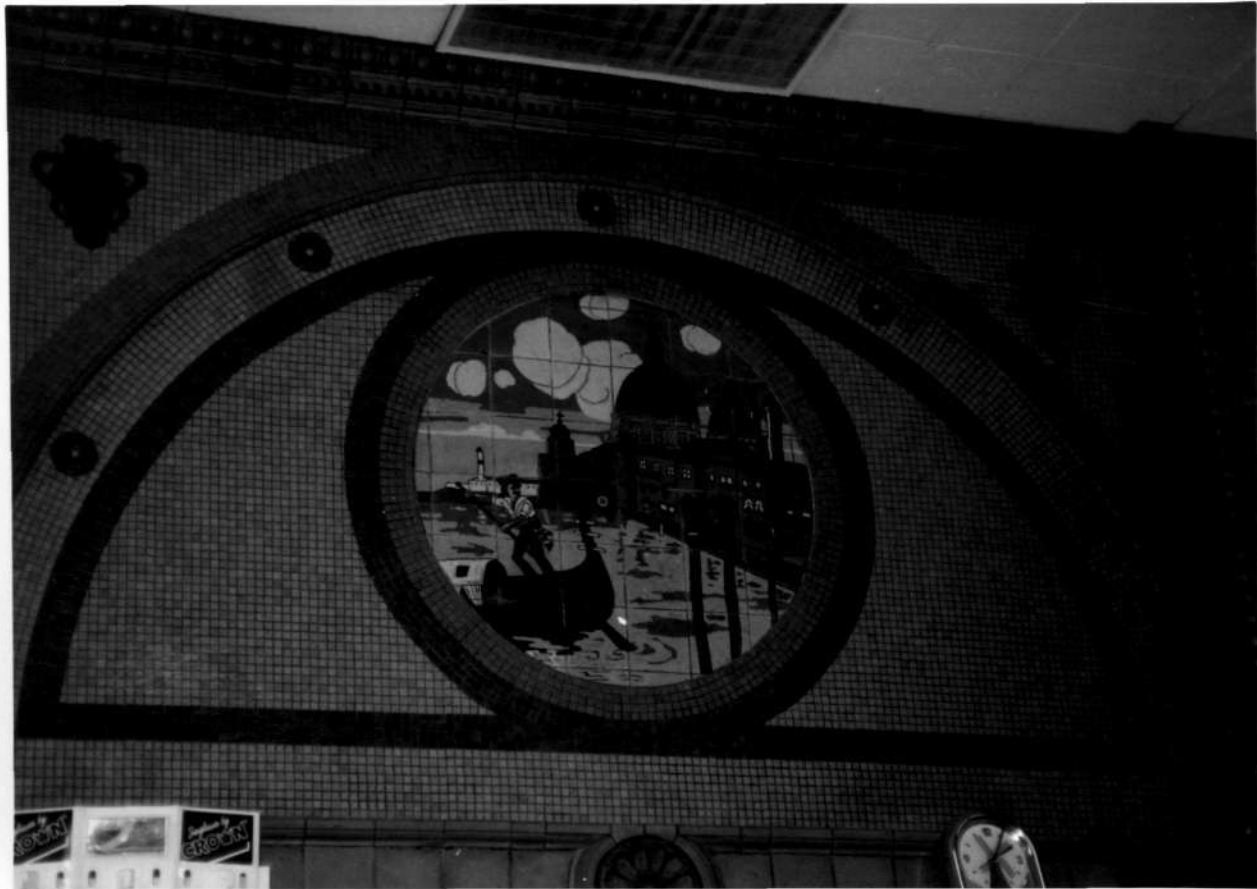
3/3

Interior detail, north wall

The north wall is divided into five bays, with raised pilasters dividing the units. The pilasters are created out of molded, bullnose tile with a border of blue and white mosaics outlining a panel of off white larger tile squares. The base of the pilasters have a blue shield with a gold "K" embossed for Kruge's Restaurant. A band of fluted tan tiles runs between the base of the pilasters (or the band can also be interpreted as an entablature running over the decorative details of the now-wallboarded lower section of the wall). In the middle of each fluted band is a floral rondel of molded tile.

The exposed upper wall of each bay is entirely covered with buff-colored mosaics. The second, third, and fourth bays have special details. The buff mosaic fields have a green mosaic arch worked into the design. The arch is outlined in tan and buff mosaics. Above the arch is a row of blue and yellow tile rosettes. The arch of the second and fourth bays is bisected by two vertical bands of green tile. The spandrels between the arches and the pilasters are decorated with blue shields with red fleur-de-lis. The arch in the third bay is filled with a round picture scene. The mosaic rondel depicts Venice, with a gondola in the canal and San Marco and the Campanile in the background. The spandrels are decorated with blue urns with red strips.

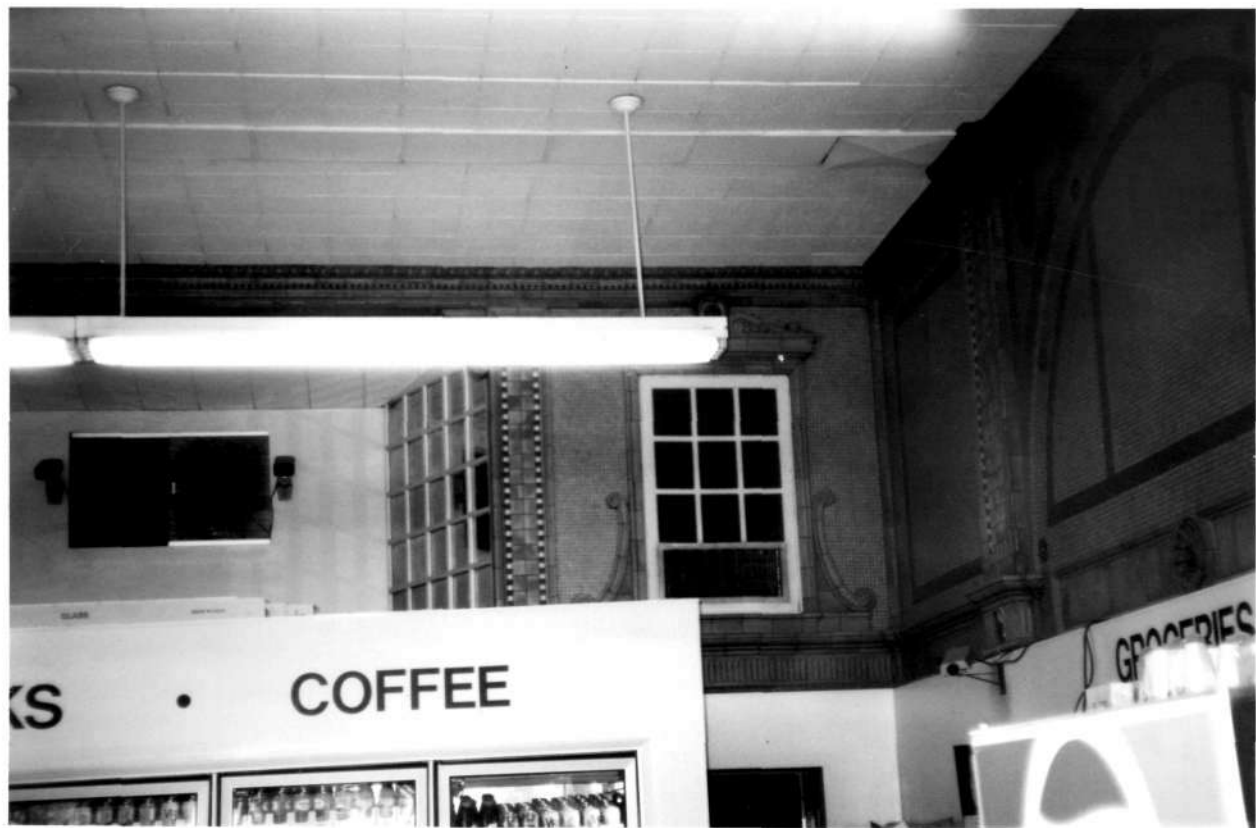
1/3

Interior, east wall

The back (east) wall has three bays. The first and third bays have 12-light windows. The bottom three lights of the first window now have ventilators. The wall surface is covered in buff mosaics. The windows have molded tile surrounds. The lintel is a back band topped with scrolls flanking a medallion with a blue fleur-de-lis. The sills are in a lyre silhouette. The middle bay is a three-sided bowed bay. The angled sides of the bow contain 20-light windows of mirror glass. The middle section of the bow is wall boarded. The fluted entablature runs across the bottom of the visible wall.

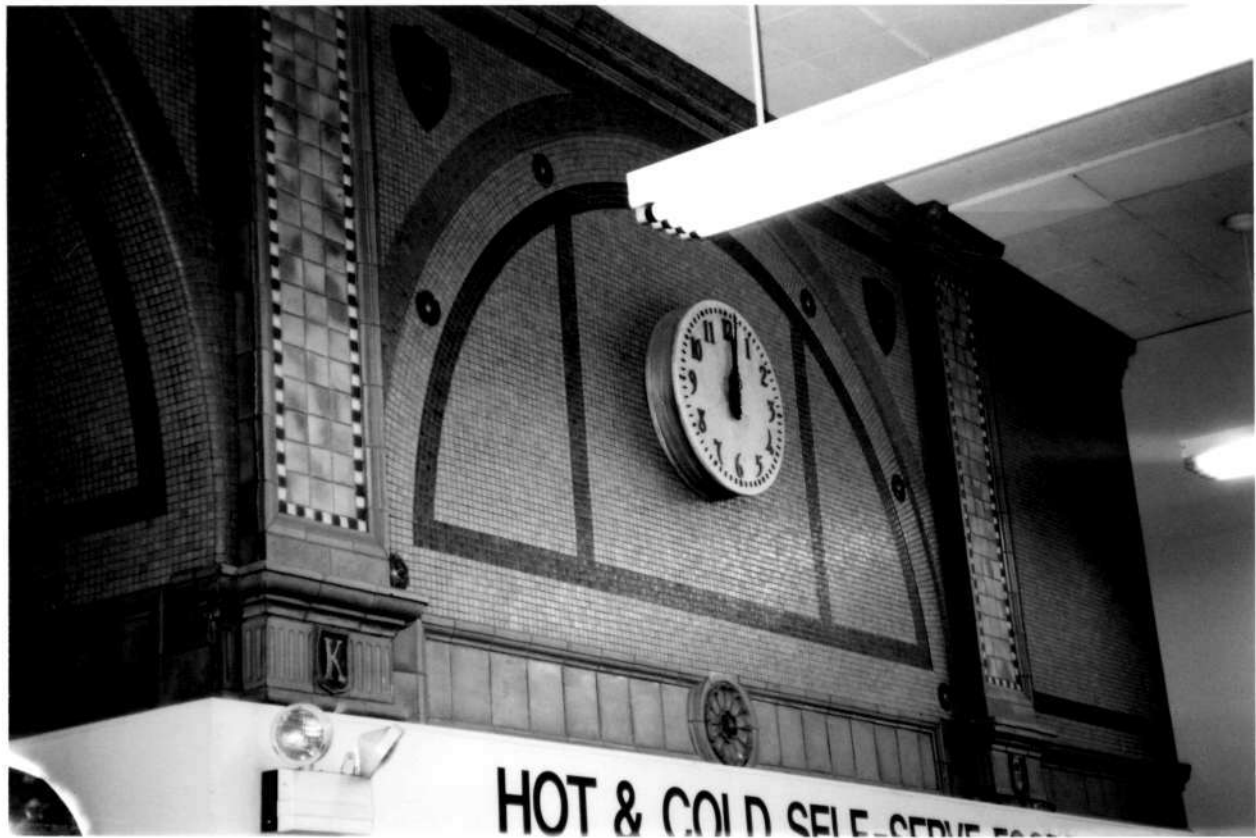
2/3

Interior, south wall

The five-bay south wall is similar to the north wall. The second and fourth bays have the bisected green mosaic arches; a now-broken marble clock is centered in the arch of the fourth bay. The rondel in the third bay contains a landscape scene of fountain in the foreground, country villa in the midground, and a smoking volcano in the background. The fourth and fifth bays extend into the room; the jut is the non-communicating staircase of #21 that leads to the upper stories. There is a cove projection that spans the void between the top of the story and the bottom of the jutting stair landing. The soffit of this cove is also tiled in buff and green mosaics.

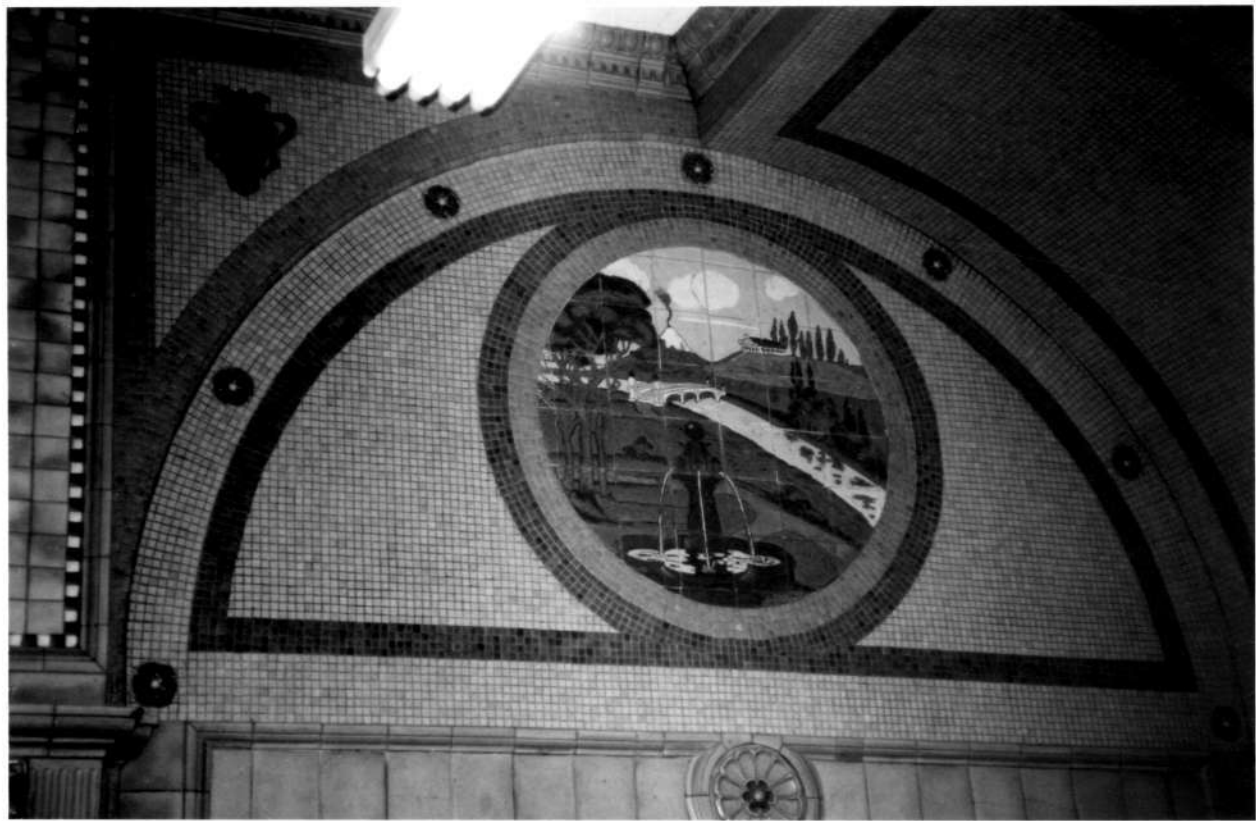
3/3

Interior, south wall
